# Manhole Inspection Summary

Manhole # S35MM\_038MH

**Location** Address: **339 21ST ST**

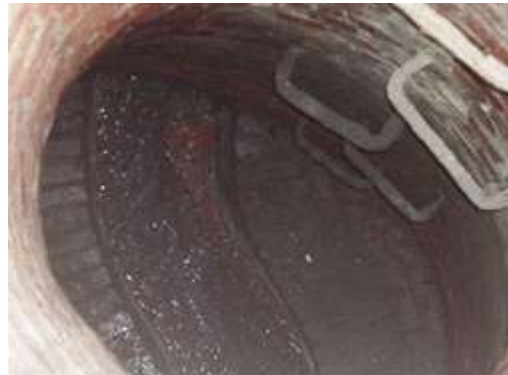
Top View

Infiltration: ☐ None ☐ Joint ☐ Cracks ☒ **Mortar** ☐ Roots ☒ **Wall**

☐ Parged ☒ **Debris** (not Condition related)

**Steps** Count: **6** Missing: **0** ☒ **Corroded**

Barrel infiltration. Bench debris. Corroded steps.

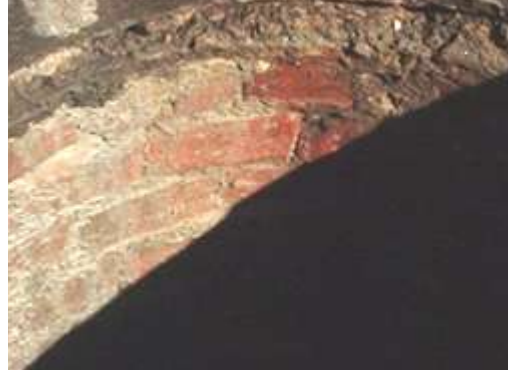
Defect

Condition: ☐ Sound ☐ Cracked ☒ **Leaks**

Condition: ☐ Sound ☐ Cracked ☐ Root Intrusion ☐ Loose Brick ☒ **Deteriorated**

Infiltration: ☐ None ☒ **Joint** ☐ Cracks ☒ **Mortar** ☐ Roots ☐ Wall

Frame leaks. Adjustment deterioration and infiltration.

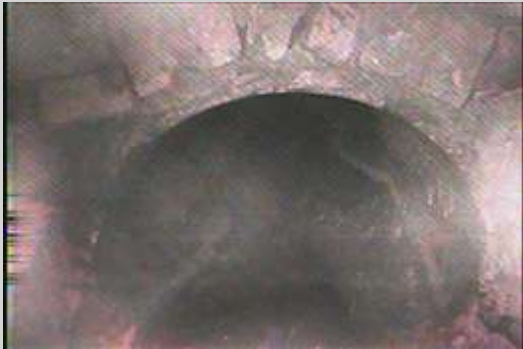
### 18 in. Circular Gravity Sewer Pipe Out @ 12 O'Clock

Deposits: ☐ None ☐ Mud ☐ Sludge ☐ Debris ☒ **Grease**

Silt Depth: **0** (in.) Deposits Extent: **Light**

Infiltration: **Evidence** Pipe Seal Cond: **Cracked**

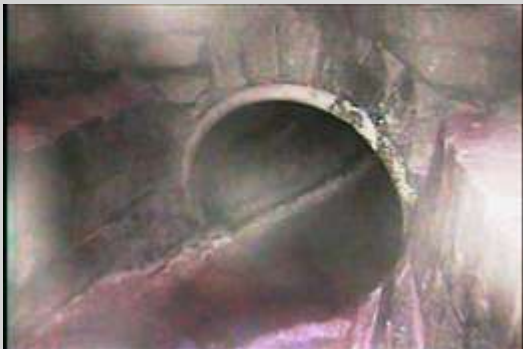
### 15 in. Circular Gravity Sewer Pipe In @ 6 O'Clock

Deposits: ☐ None ☐ Mud ☐ Sludge ☐ Debris ☒ **Grease**

Silt Depth: **0** (in.) Deposits Extent: **Light**

Infiltration: **None** Pipe Seal Cond: **Cracked**
